**Flood Control Project Maintenance
Levee Inspections**
LMA District Cover Sheet
Spring 2019 Levee Inspection Results

Reclamation District No. 0544 Upper Roberts Island

Waterway			Bank	Unit Miles
Unit No. 01 San Joaquin River			Left	6.05
	Spring (March - May)	Summer (June - August)	(September - November) Fall	Winter (December - February)
Unit Maintenance Rating (Fall Only)				
Date of Inspection	5/9/2019 - 5/9/2019			
DWR Inspector	Alberto De Leon			
Accompanied By	Jerry Robinson

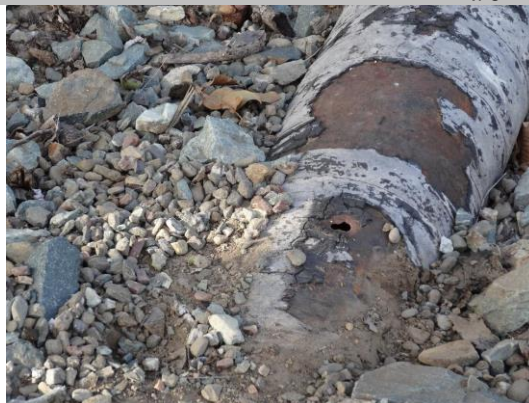
Photo 2 of 3 : UCIP_SP_2019_23851_41727.jpg

LM Start	0.01	Rating **	M	Issue No.	151 (cont)
LM End	0.01	Issue Type +	En	Location *

LS view: a 12-inch steel pipe on levee slope. Holes on the pipe, appears abandoned.

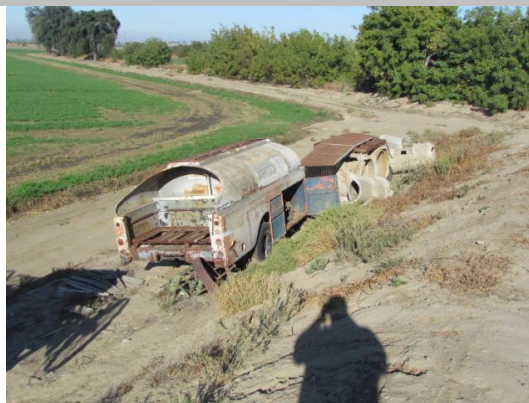
Photo 1 of 5 : SP_2019_RD0544_108_4_20190313_00005.jpg

LM Start	0.06	Rating **	M	Issue No.	4
LM End	0.23	Issue Type +	En	Location *	LS
Category	Earthen Levee			GPS Latitude/Longitude	
				Start	End
Item	Encroachments			37.869606 °	37.867580 °
				-121.329571 °	-121.327791 °
DWR ID	DWR_RD0544_01_s_2012_4				
Comment Code					
EQ : Equipment					
Inspector Comment					
Farm equipment and supplies are stored at landside toe.

Looking west at equipment stored at landward toe fall 2015

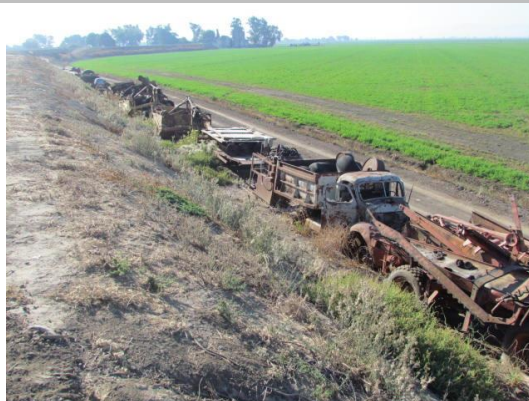
Photo 2 of 5 : SP_2019_RD0544_108_4_20190313_00006.jpg

Looking southwest at equipment stored at landward toe fall 2015.

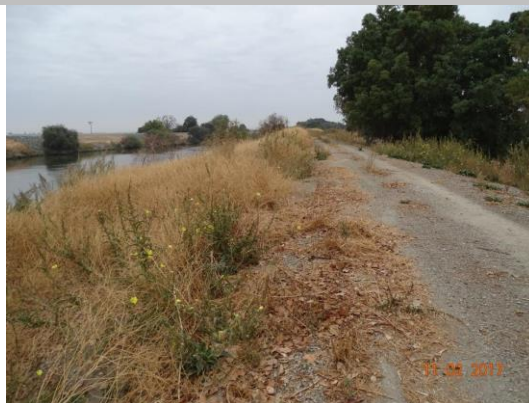
Photo 1 of 2 : SP_2019_RD0544_108_3_20190313_00003.jpg

LM Start	0.48	Rating **	M	Issue No.	3
LM End	0.57	Issue Type +	Ma	Location *	WS
Category	Earthen Levee			GPS Latitude/Longitude	
				Start	End
Item	Vegetation			37.864578 °	37.864312 °
				-121.326210 °	-121.324576 °
DWR ID	DWR_RD0544_01_s_2012_3				
Comment Code					
V1 : Control annual grass and weeds on the levee slopes and easements.					
Inspector Comment

Looking southeast at the waterside slope.

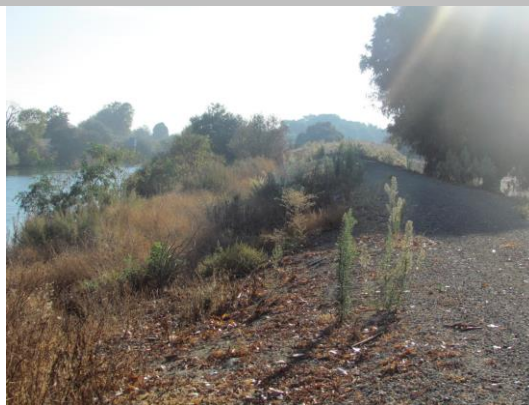
Photo 2 of 2 : SP_2019_RD0544_108_3_20190313_00004.jpg

Looking south at dense veg on waterward slope.

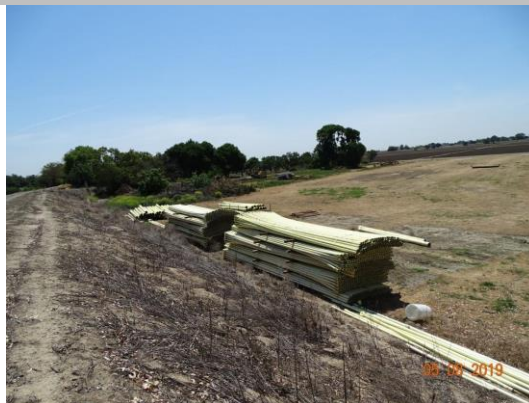
Photo 1 of 1 : SP_2019_RD0544_108_54_20190523_00159.jpg

LM Start	0.58	Rating **	U	Issue No.	54
LM End	0.58	Issue Type +	En	Location *	LS
Category	Earthen Levee			GPS Latitude/Longitude	
				Start	End
Item	Encroachments			37.864268 °	37.864268 °
				-121.324396 °	-121.324396 °
DWR ID	DWR_RD0544_01_s_2019_54				
Comment Code					
EQ : Equipment					
Inspector Comment					
Farmer is storing irrigation pipe within landside easement.

View of irrigation pipes being stored in landside toe easement. (Spring 2019)

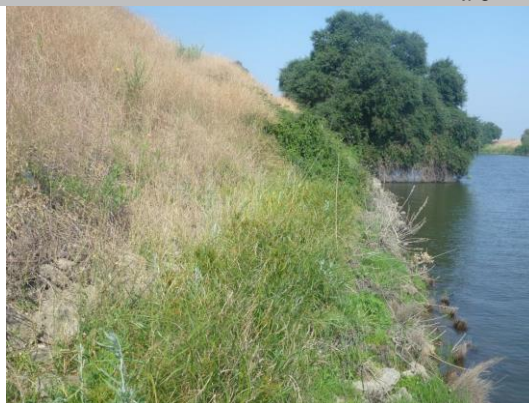
Photo 1 of 3 : LEVAL_SP_2019_571_4478.jpg

LM Start	0.64	Rating **	A/W	Issue No.	75
LM End	0.64	Issue Type +	Ma	Location *	
Category	Supplemental			GPS Latitude/Longitude	
				Start	End
Item	2017 Storm Damage			37.863900 °	37.863900 °
				-121.323500 °	-121.323400 °
DWR ID	DWR_RD0544_01_f_2017_75				
Comment Code					
Inspector Comment					
Levee Evaluation Comments					
Description:Slope protection repairs are needed along the waterside slope due to erosion and riprap displacement from high water. Based upon levee inspections, it was determined the waterside levee slope is eroding, deteriorating, and degrading. The eroded levee sections need to be restored back to design standards to prevent further deterioration and damage.					
Site ID No:571					
Site Designation:LMA-477					
Repair Type: Erosion					
Rating:Area of Concern					
Field Date:8/10/2017					
Notes:

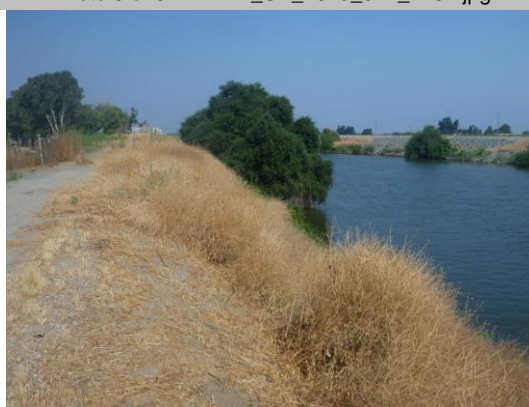
Photo 3 of 3 : LEVAL_SP_2019_571_4487.jpg

LM Start	0.64	Rating **	A/W	Issue No.	75 (cont)
LM End	0.64	Issue Type +	Ma	Location *

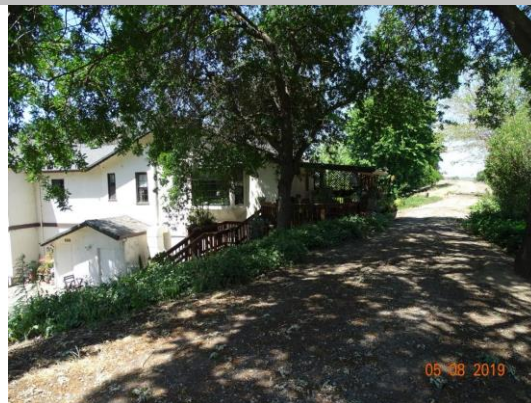
Photo 1 of 1 : SP_2019_RD0544_108_55_20190523_00160.jpg

LM Start	0.70	Rating **	U	Issue No.	55
LM End	0.70	Issue Type +	En	Location *	LS
Category	Earthen Levee			GPS Latitude/Longitude	
				Start	End
Item	Encroachments			37.863576 °	37.863576 °
				-121.322327 °	-121.322327 °
DWR ID	DWR_RD0544_01_s_2019_55				
Comment Code					
BU : Building					
Inspector Comment					
There is a residential building on the landside slope.

View of residential building on landside slope. (Spring 2019)

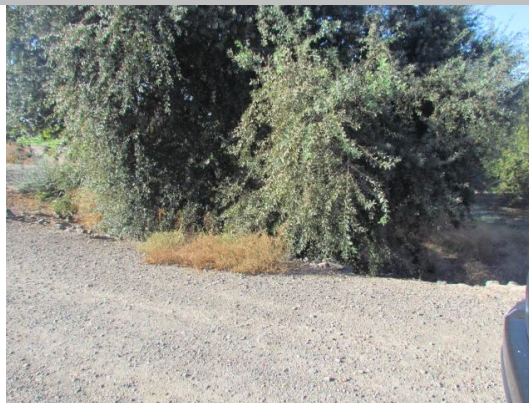
Photo 1 of 1 : SP_2019_RD0544_108_93_20190313_00061.jpg

LM Start	0.81	Rating **	M	Issue No.	93
LM End	0.81	Issue Type +	Ma	Location *	LS
Category	Earthen Levee			GPS Latitude/Longitude	
				Start	End
Item	Trim / Thin Trees			37.862694 °	37.862694 °
				-121.320887 °	-121.320887 °
DWR ID	DWR_RD0544_01_f_2014_93				
Comment Code					
T1 : Trim trees to at least five feet above ground level.					
Inspector Comment

Looking west at untrimmed trees on landward slope and toe, Fall 2015.

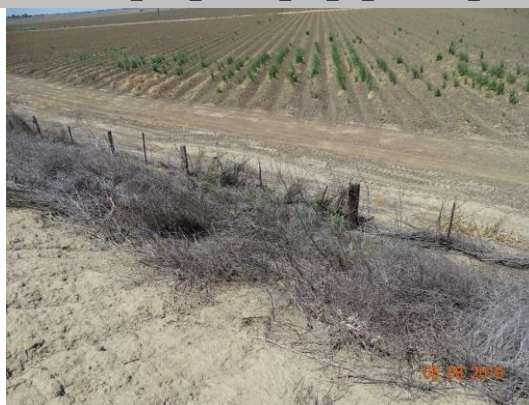
Photo 1 of 1 : SP_2019_RD0544_108_58_20190523_00161.jpg

LM Start	0.83	Rating **	M	Issue No.	58
LM End	1.31	Issue Type +	En	Location *	LS
Category	Earthen Levee			GPS Latitude/Longitude	
				Start	End
Item	Encroachments			37.862312 °	37.857169 °
				-121.320889 °	-121.320224 °
DWR ID	DWR_RD0544_01_s_2019_58				
Comment Code					
FE : Fence					
Inspector Comment					
There is a barbed wire fence near the landside toe and within the easement.

View of barbed wire fence near landside toe and within easement.
(Spring 2019)

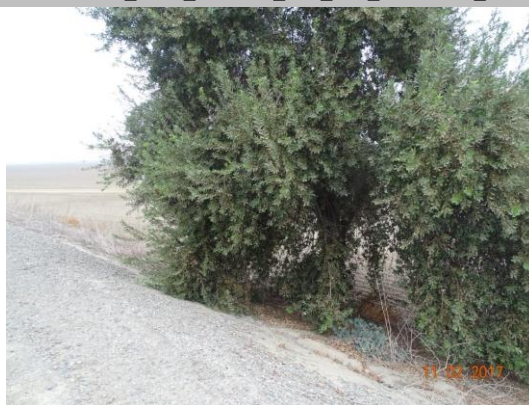
Photo 1 of 1 : SP_2019_RD0544_108_145_20190313_00115.jpg

LM Start	1.64	Rating **	M	Issue No.	145
LM End	1.64	Issue Type +	Ma	Location *	LS
Category	Earthen Levee			GPS Latitude/Longitude	
				Start	End
Item	Trim / Thin Trees			37.854673 °	37.854673 °
				-121.322492 °	-121.322492 °
DWR ID	DWR_RD0544_01_f_2017_145				
Comment Code					
T1 : Trim trees to at least five feet above ground level.					
Inspector Comment

Looking northwest at the landside slope.

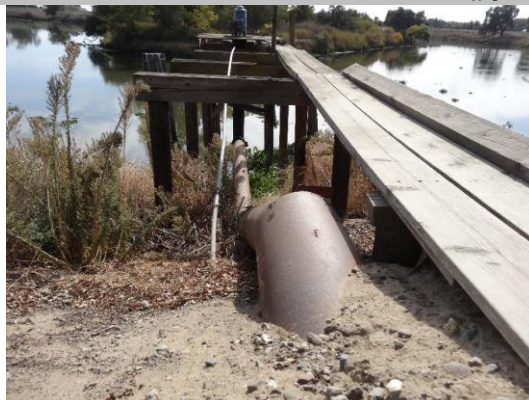
Photo 1 of 3 : UCIP_SP_2019_51351_41786.jpg

Comment Code						
Inspector Comment						
FS_ID:51351 DS_ID:22648 EP_NO: 4114 Repair Type: Non-Urgent Crossing Status: Found UCIP Comments: 12/22/2016: No signs of erosion or depressions found on either levee slope. Slope may have been backfilled but cause of original depression (likely a pipe integrity problem) may not have been addressed. Walkway still in poor structural condition. Downgraded this crossing from Urgent to Non-Urgent. (K. Fazel - UCIP)10/29/2013:- levee depression on both sides of the levee.- 2-inch electric conduit on waterside and service pole on landside.Walkway in poor structural condition. (P. Amatya - DWR) FIELD_STRUCT_DESC: 18-inch steel irrigation discharge pipe through the levee, 2 feet below the crown. Pump mounted on a pile structure pier in the river. Siphon breaker on the apex of the pipe on the landside (LS) slope. Concrete standpipe at the LS toe. 2-inch electrical conduit through the levee. Service pole at the LS toe. (Plans to install a pump, pump structure, and one 20-inch pipeline through the levee authorized under Permit No. 4114, 1962 - Katie M. Feck). [Additional Reference(s): DWR Levee Log, 2005, 14-inch pipe referenced, 4.2 feet below the crown. USACE San Joaquin O&M Manual 7, April 1964, (HLM 1.73), 20-inch pipe, 4.2 feet below the crown, referenced]. FS Date: 12/22/2016

WS view: pipe, conduit, walkway, and pump on levee slope.

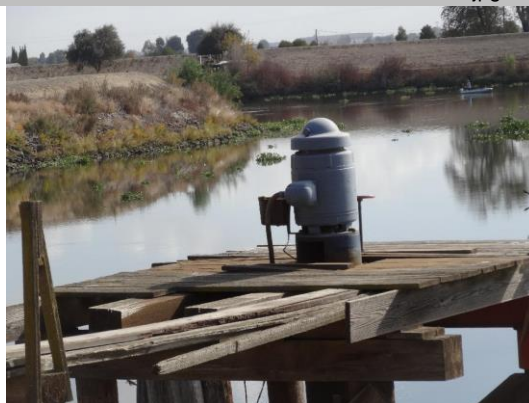
Photo 2 of 3 : UCIP_SP_2019_51351_41785.jpg

WS view: pump on wooden pile structure in the stream.

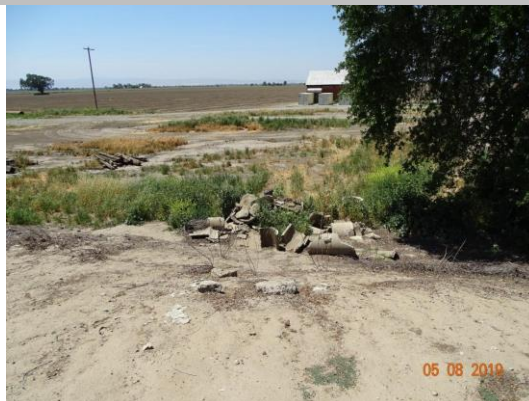
Photo 1 of 2 : SP_2019_RD0544_108_70_20190523_00163.jpg

LM Start	1.83	Rating **	M	Issue No.	70
LM End	1.86	Issue Type +	En	Location *	LS
Category	Earthen Levee			GPS Latitude/Longitude	
				Start	End
Item	Encroachments			37.853006 °	37.852683 °
				-121.324100 °	-121.323972 °
DWR ID	DWR_RD0544_01_s_2019_70				
Comment Code					
DE : Debris					
Inspector Comment					
Concrete rubble, firewood, limbs, and branches are located on the landside slope and toe.

View on concrete rubble on landside slope and toe. (Spring 2019)

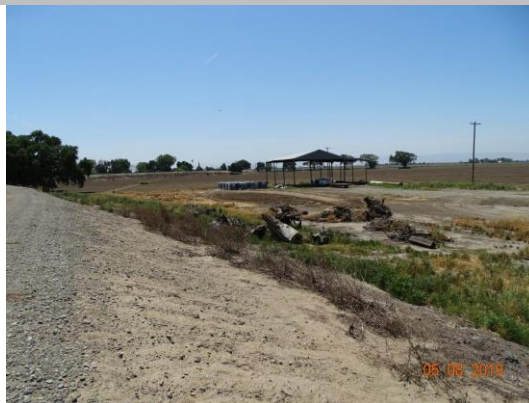
Photo 2 of 2 : SP_2019_RD0544_108_70_20190523_00164.jpg

LM Start	1.83	Rating **	M	Issue No.	70 (cont)	
LM End	1.86	Issue Type +	En	Location *	LS	
Category	Earthen Levee			GPS Latitude/Longitude		
				Start		End
Item	Encroachments			37.853006 °	37.852683 °	
				-121.324100 °	-121.323972 °	
DWR ID	DWR_RD0544_01_s_2019_70					
Comment Code						
DE : Debris						
Inspector Comment						
Concrete rubble, firewood, limbs, and branches are located on the landside slope and toe.

View of tree limbs and branches on landside slope and toe. (Spring 2019)

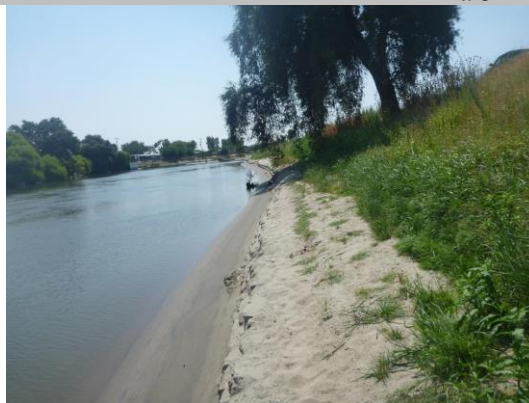
LM Start	1.89	Rating **	A/W	Issue No.	127
LM End	1.91	Issue Type +	Ma	Location *	
Category	Supplemental			GPS Latitude/Longitude	
				Start	End
Item	2017 Storm Damage			37.852300 °	37.852000 °
				-121.323700 °	-121.323600 °
DWR ID	DWR_RD0544_01_f_2017_127				
Comment Code					
Inspector Comment					
Levee Evaluation Comments					
Description:Slope protection repairs are needed along the waterside slope due to erosion and riprap displacement from high water. Based upon levee inspections, it was determined the waterside levee slope is eroding, deteriorating, and degrading. The eroded levee sections need to be restored back to design standards to prevent further deterioration and damage.					
Site ID No:569					
Site Designation:LMA-475					
Repair Type: Erosion					
Rating:Area of Concern					
Field Date:8/10/2017					
Notes:

LM Start	1.89	Rating **	A/W	Issue No.	127 (cont)
LM End	1.91	Issue Type +	Ma	Location *	
Category	Supplemental			GPS Latitude/Longitude	
				Start	End
Item	2017 Storm Damage			37.852300 °	37.852000 °
				-121.323700 °	-121.323600 °
DWR ID	DWR_RD0544_01_f_2017_127				
Comment Code					
Inspector Comment					
Levee Evaluation Comments					
Description:Slope protection repairs are needed along the waterside slope due to erosion and riprap displacement from high water. Based upon levee inspections, it was determined the waterside levee slope is eroding, deteriorating, and degrading. The eroded levee sections need to be restored back to design standards to prevent further deterioration and damage.					
Site ID No:569					
Site Designation:LMA-475					
Repair Type: Erosion					
Rating:Area of Concern					
Field Date:8/10/2017					
Notes:

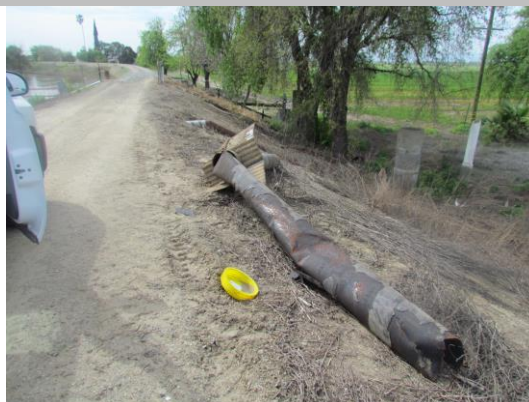
Photo 1 of 1 : SP_2019_RD0544_108_82_20190313_00053.jpg

LM Start	2.25	Rating **	M	Issue No.	82
LM End	2.25	Issue Type +	Ma	Location *	LS
Category	Earthen Levee			GPS Latitude/Longitude	
				Start	End
Item	Encroachments			37.848302 °	37.848302 °
				-121.324877 °	-121.324877 °
DWR ID	DWR_RD0544_01_s_2017_82				
Comment Code					
EQ : Equipment					
Inspector Comment					
An old irrigation pipe needs to be removed.

Looking southwest at old irrigation pipe on landward shoulder.

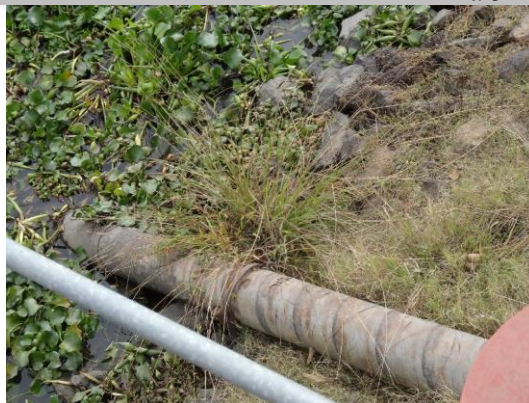
Photo 1 of 3 : UCIP_SP_2019_53363_44830.jpg

Comment Code					
Inspector Comment					
FS_ID:53363 DS_ID:22652 EP_NO: 13554 Repair Type: Urgent Crossing Status: Found UCIP Comments: 10/2/2018 Significant erosion on LS slope and around pipe, also noticed significant erosion on WS slope so crossing remains as Urgent (D. Sanoski - DWR UCIP).12/22/2016: Depression (hole) in levee in two places on the WS slope in alignment with this pipe. One of the holes is due to rodent activity. Crossing has been upgraded from Non-Urgent to Urgent. (K. Fazel - UCIP)10/29/2013:- levee slope erosion on landside.- needs cleaning of siphon breaker. (P. Amatya - DWR) FIELD_STRUCT_DESC: 12-inch coated steel drainage discharge pipe, 2 feet below the crown. Pump in a concrete standpipe in a drainage ditch at the landside (LS) toe. Siphon breaker in a steel riser on the waterside (WS). (Plans to install a 12-inch discharge pipe through the levee for removal of excess waters authorized under Permit No. 13554, 1982 - Lloyd Phelps Jr. [Additional Reference(s): DWR Levee Log, 2005, states that the pump is on a pier in the channel]. FS Date: 10/2/2018 2:34:00 PM

WS view: steel pipe immersed into the stream.

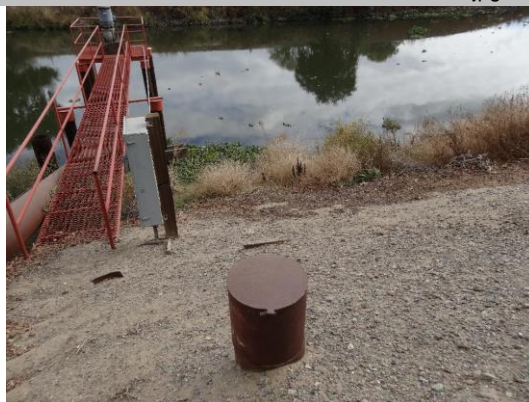
Photo 2 of 3 : UCIP_SP_2019_53363_44829.jpg

WS view: siphon breaker inside steel pipe riser (bottom) on levee slope.

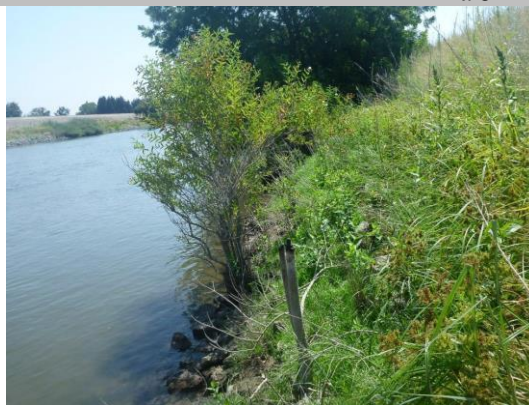
Photo 3 of 3 : LEVAL_SP_2019_568_4547.jpg

LM Start	2.31	Rating **	A/W	Issue No.	128 (cont)
LM End	2.35	Issue Type +	Ma	Location *	
Category	Supplemental			GPS Latitude/Longitude	
				Start	End
Item	2017 Storm Damage			37.847300 °	37.846800 °
				-121.324700 °	-121.324400 °
DWR ID	DWR_RD0544_01_f_2017_128				
Comment Code					
Inspector Comment					
Levee Evaluation Comments					
Description:Slope protection repairs are needed along the waterside slope due to erosion and riprap displacement from high water. Based upon levee inspections, it was determined the waterside levee slope is eroding, deteriorating, and degrading. The eroded levee sections need to be restored back to design standards to prevent further deterioration and damage.					
Site ID No:568					
Site Designation:LMA-474					
Repair Type: Erosion					
Rating:Area of Concern					
Field Date:8/10/2017					
Notes:

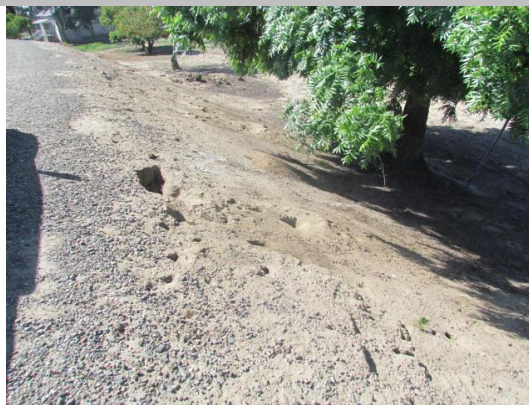
Photo 2 of 3 : SP_2019_RD0544_108_34_20190313_00024.jpg

Looking south at several rodent holes on landward shoulder and slope.

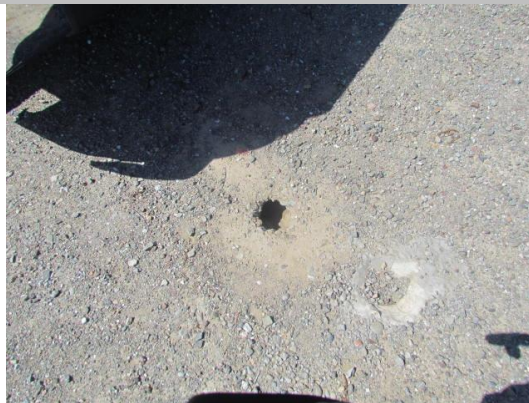
Photo 3 of 3 : SP_2019_RD0544_108_34_20190313_00025.jpg

Looking at rodent hole on levee crown.

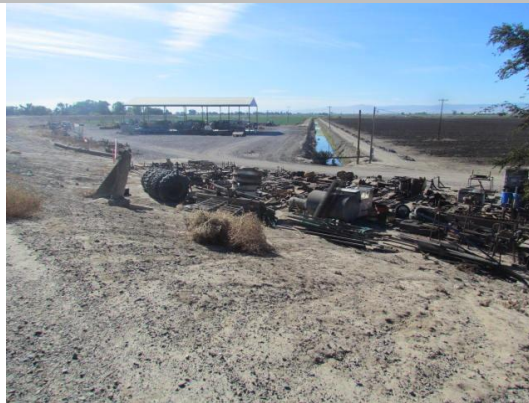
Photo 1 of 1 : SP_2019_RD0544_108_68_20190313_00043.jpg

LM Start	2.37	Rating **	U	Issue No.	68
LM End	2.43	Issue Type +	En	Location *	LS
Category	Earthen Levee			GPS Latitude/Longitude	
				Start	End
Item	Encroachments			37.846635 °	37.845981 °
				-121.324217 °	-121.323380 °
DWR ID	DWR_RD0544_01_s_2013_68				
Comment Code					
EQ : Equipment					
Inspector Comment					
There is equipment on the landside toe.

Looking west at equipment at landward toe.

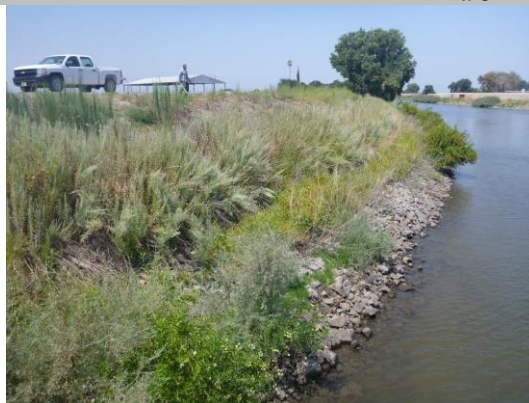
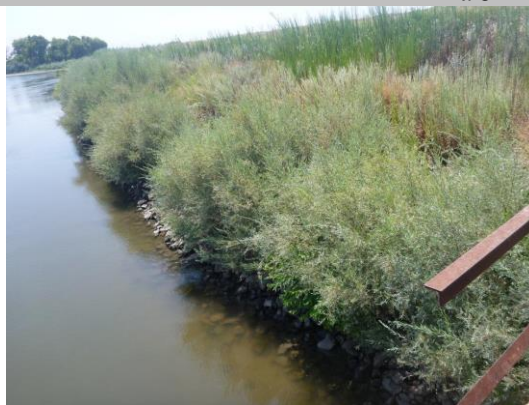
LM Start	2.53	Rating **	A/W	Issue No.	129 (cont)
LM End	2.56	Issue Type +	Ma	Location *	
Category	Supplemental			GPS Latitude/Longitude	
				Start	End
Item	2017 Storm Damage			37.844900 °	37.844500 °
				-121.322300 °	-121.321900 °
DWR ID	DWR_RD0544_01_f_2017_129				
Comment Code					
Inspector Comment					
Levee Evaluation Comments					
Description:Slope protection repairs are needed along the waterside slope due to erosion and riprap displacement from high water. Based upon levee inspections, it was determined the waterside levee slope is eroding, deteriorating, and degrading. The eroded levee sections need to be restored back to design standards to prevent further deterioration and damage.					
Site ID No:567					
Site Designation:LMA-473					
Repair Type: Erosion					
Rating:Area of Concern					
Field Date:8/10/2017					
Notes: large rodent holes observed on landside slope.

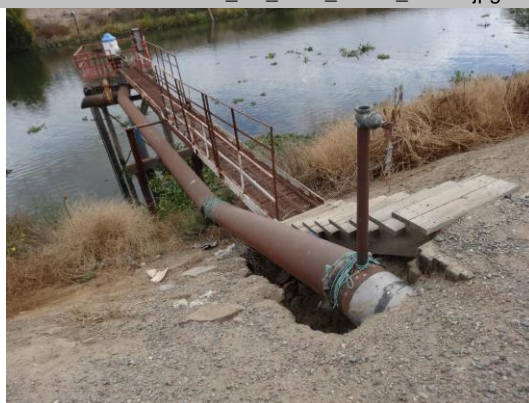
Photo 1 of 3 : UCIP_SP_2019_51361_44839.jpg

WS view: exposed pipe, walkway to pump, and pump on pile structure in the stream.

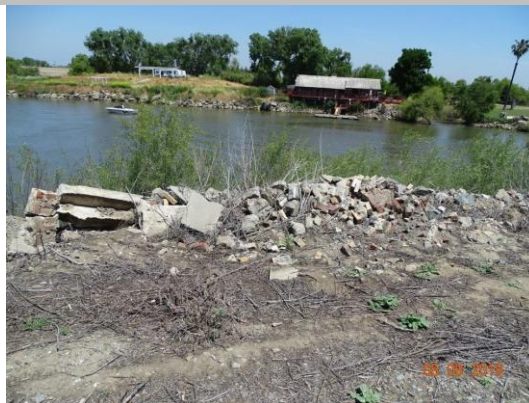
Photo 1 of 1 : SP_2019_RD0544_108_86_20190523_00165.jpg

LM Start	2.96	Rating **	U	Issue No.	86
LM End	2.96	Issue Type +	En	Location *	WS
Category	Earthen Levee			GPS Latitude/Longitude	
				Start	End
Item	Encroachments			37.840466 °	37.840466 °
				-121.318333 °	-121.318333 °
DWR ID	DWR_RD0544_01_s_2019_86				
Comment Code					
DE : Debris					
Inspector Comment

View of concrete rubble pile on waterside slope. (Spring 2019)

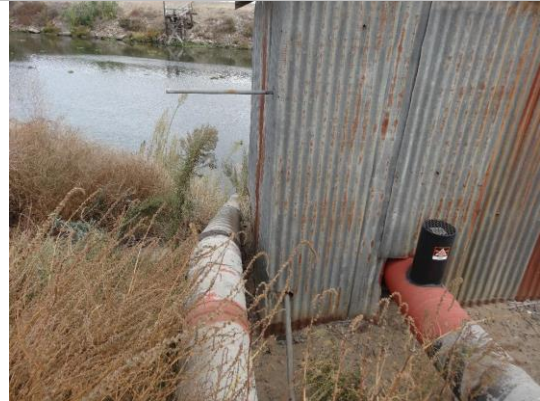
Photo 3 of 3 : UCIP_SP_2019_51366_44843.jpg

Comment Code						
Inspector Comment						
FS_ID:51366 DS_ID:22681 EP_NO: N/A Repair Type: Non-Urgent Crossing Status: Found UCIP Comments: 12/22/2016: Giant pit in LS slope has been backfilled, though no permit uncovered for this work. Unclear whether original source of damage (likely a leak in pipe) was addressed. Crossing has been downgraded from Urgent to Non-Urgent. (K. Fazel - UCIP)10/29/2013:Huge erosion and levee damage on landside slope due to the leaky pipe. Walkway to distro box on LS toe in poor structural condition. (P. Amatya - DWR) FIELD_STRUCT_DESC: 2 of 2: 14-inch steel irrigation discharge pipe through the levee, 8 feet below the crown. Slide gate in a 6-foot by 6-foot concrete distribution box at the landside (LS) toe. 1-inch electrical conduit through the levee. Power pole at the LS toe. Pump house on the waterside (WS) slope, but no pump attached as per the 2013 inspection. Flow meter on the WS. [Additional Reference(s): DWR Levee Log, 2005. USACE San Joaquin O&M Manual 7, April 1964, (HLM 3.19)]. FS Date: 12/22/2016

WS view: exposed steel pipe (right) with flow meter near pump house.

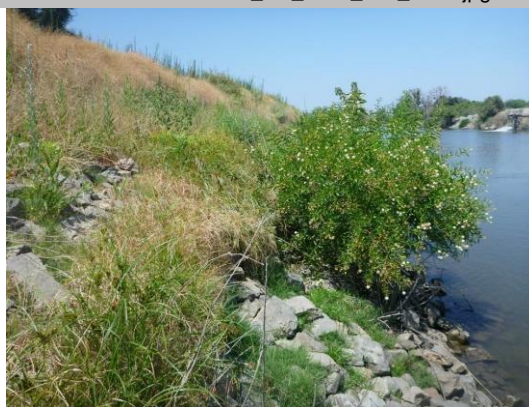
Photo 2 of 3 : LEVAL_SP_2019_566_4717.jpg

LM Start	3.21	Rating **	A/W	Issue No.	131 (cont)
LM End	3.22	Issue Type +	Ma	Location *

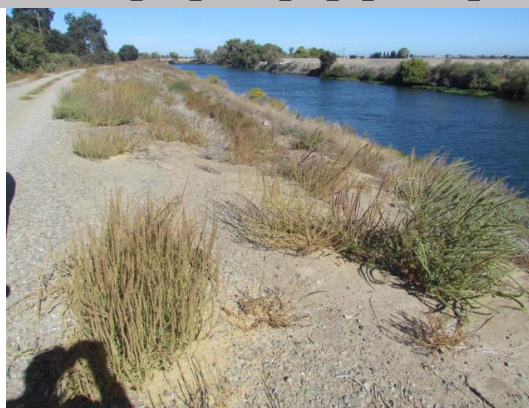
Photo 1 of 1 : SP_2019_RD0544_108_37_20190313_00026.jpg

LM Start	3.28	Rating **	M	Issue No.	37
LM End	3.28	Issue Type +	En	Location *	WS
Category	Earthen Levee			GPS Latitude/Longitude	
				Start	End
Item	Encroachments			37.835951 °	37.835951 °
				-121.317062 °	-121.317062 °
DWR ID	DWR_RD0544_01_s_2012_37				
Comment Code					
RA : Ramp					
Inspector Comment					
The landowner has cut a ramp on waterside slope.

Looking north at ramp on waterward slope.

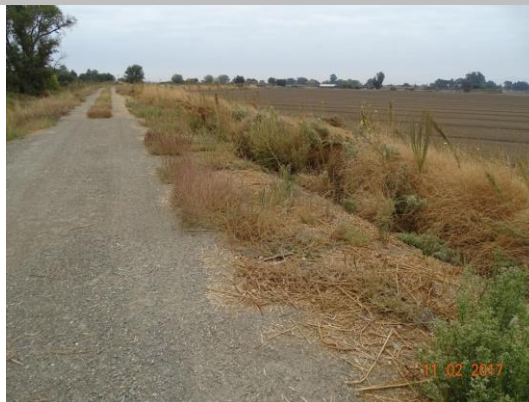
Photo 1 of 1 : SP_2019_RD0544_108_51_20190313_00039.jpg

LM Start	3.49	Rating **	U	Issue No.	51
LM End	4.74	Issue Type +	Ma	Location *	LS
Category	Earthen Levee			GPS Latitude/Longitude	
				Start	End
Item	Vegetation			37.833432 °	37.821319 °
				-121.314792 °	-121.320875 °
DWR ID	DWR_RD0544_01_s_2012_51				
Comment Code					
V2 : Remove the wild growth other than native grasses from the levee slopes.					
Inspector Comment

Looking southeast at the landside slope.

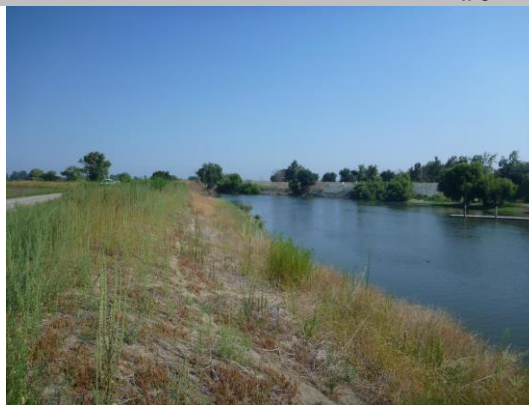
Photo 3 of 3 : LEVAL_SP_2019_564_4756.jpg

LM Start	3.69	Rating **	A/W	Issue No.	133 (cont)
LM End	3.73	Issue Type +	Ma	Location *

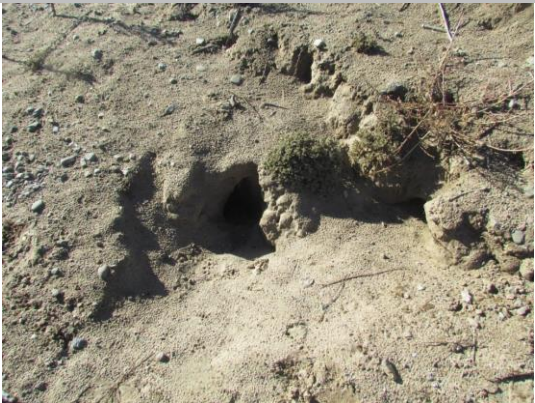
Photo 1 of 1 : SP_2019_RD0544_108_11_20190313_00017.jpg

Looking at large rodent holes on waterward slope.

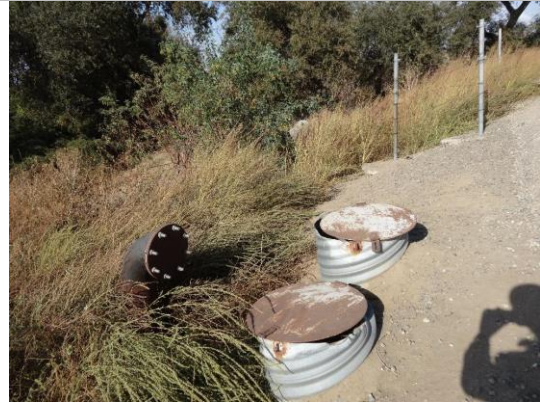
Photo 3 of 3 : UCIP_SP_2019_24893_44856.jpg

Comment Code						
Inspector Comment						
FS_ID:24893 DS_ID:22660 EP_NO: 11536 Repair Type: Non-Urgent Crossing Status: Found UCIP Comments: - siphon breaker was removed from CMP riser on landside shoulder. Needs replacement.- some details about existing pipes available in new Application no. 18903.- electric control box on landside and conduit on waterside. FIELD_STRUCT_DESC: 1 of 3: 12-inch coated steel irrigation discharge pipe through the levee, 3 feet below the crown. Pump on a pumping platform in the river with a walkway from the waterside (WS) slope. Siphon breaker in a corrugated metal pipe (CMP) riser and a concrete standpipe on the landside (LS). (Plans to install a platform and two irrigation pumps with two irrigation pipes and a drainage pipe through the levee, replacing an existing pump and irrigation pipe, authorized under Permit No. 11536, 1976 - Lloyd L. Phelps Sr). [Additional Reference(s): DWR Levee Log, 2005. USACE San Joaquin O&M Manual 7, April 1964, (HLM 4.33), pipe referenced as 8 feet below the crown]. FS Date: 10/29/2013

LS view: CMP riser (top- for 12" pipe), CMP riser (bottom- for 16" pipe), and capped steel pipe (left)

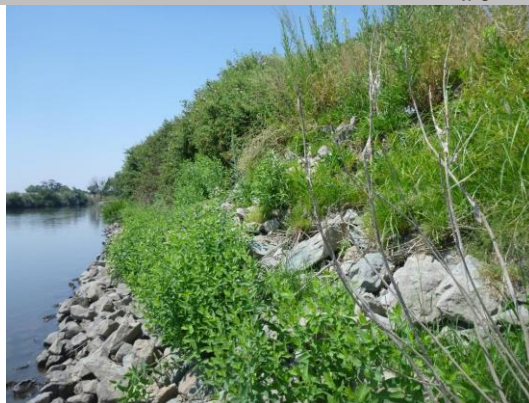
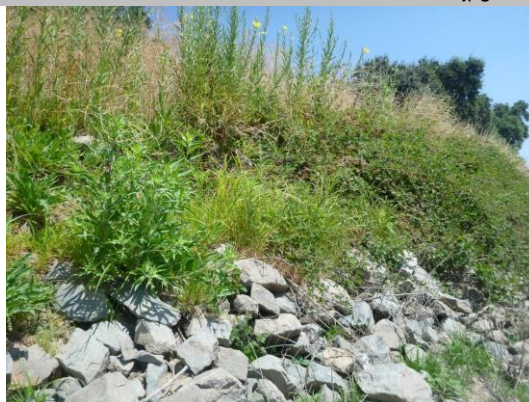
Comment Code					
Inspector Comment					
Levee Evaluation Comments					
Description:Slope protection repairs are needed along the waterside slope due to erosion and riprap displacement from high water. Based upon levee inspections, it was determined the waterside levee slope is eroding, deteriorating, and degrading. The eroded levee sections need to be restored back to design standards to prevent further deterioration and damage.					
Site ID No:561					
Site Designation:LMA-467					
Repair Type: Erosion					
Rating:Area of Concern					
Field Date:8/11/2017					
Notes: site combined with LMA-466 in field; length and coordinates redefined in field.

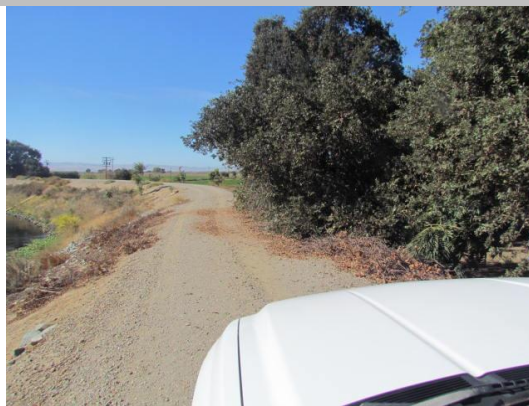
Photo 1 of 1 : SP_2019_RD0544_108_105_20190313_00065.jpg

LM Start	4.69	Rating **	U	Issue No.	105
LM End	4.69	Issue Type +	Ma	Location *	LS
Category	Earthen Levee			GPS Latitude/Longitude	
				Start	End
Item	Trim / Thin Trees			37.821775 °	37.821775 °
				-121.320203 °	-121.320203 °
DWR ID	DWR_RD0544_01_f_2014_105				
Comment Code					
T2 : Thin trees to allow visibility of the ground and room to flood fight.					
Inspector Comment					
A tree has overgrown onto the levee crown.

Looking south at overgrown tree on landward shoulder.

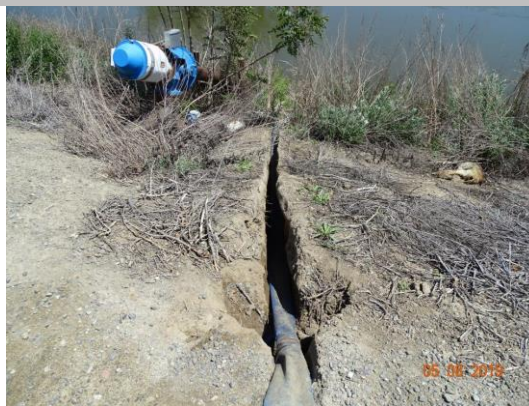
Photo 1 of 3 : SP_2019_RD0544_108_84_20190523_00167.jpg

LM Start	4.75	Rating **	U	Issue No.	84
LM End	4.75	Issue Type +	En	Location *	WS
Category	Earthen Levee			GPS Latitude/Longitude	
				Start	End
Item	Encroachments			37.821159 °	37.821159 °
				-121.320989 °	-121.320989 °
DWR ID	DWR_RD0544_01_s_2019_84				
Comment Code					
PI : Pipe					
Inspector Comment					
An unpermitted 6" flexible water line/hose is extending from the landside over the crown to the waterside slope. There is an open trench on the wateride slope, up to 24" deep. A field investigation report will be completed. Follow up with the District and CVFPB.

View of 6 inch water line and open trench on waterside slope. (Spring 2019)

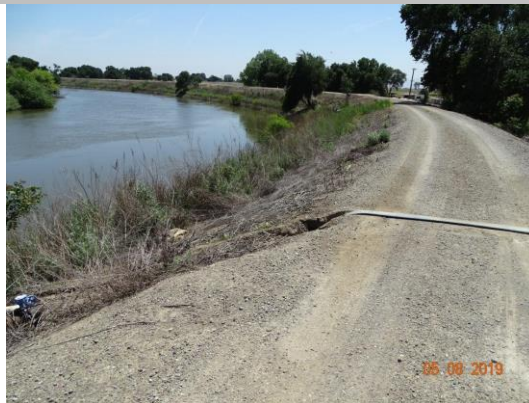
Photo 2 of 3 : SP_2019_RD0544_108_84_20190523_00168.jpg

View of 6 inch water line crossing the levee crown. (Spring 2019)

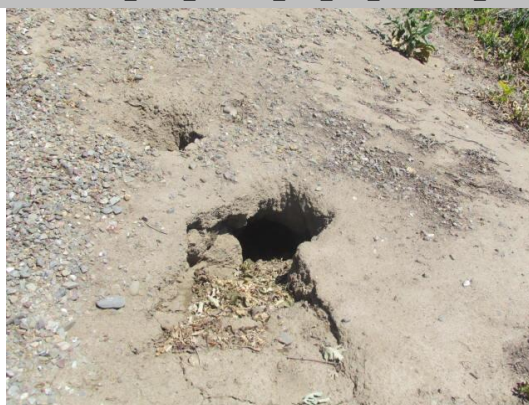
Photo 1 of 1 : SP_2019_RD0544_108_113_20190313_00070.jpg

LM Start	4.77	Rating **	U	Issue No.	113
LM End	4.77	Issue Type +	Ma	Location *	WS
Category	Earthen Levee			GPS Latitude/Longitude	
				Start	End
Item	Animal Control			37.820828 °	37.820828 °
				-121.321193 °	-121.321193 °
DWR ID	DWR_RD0544_01_s_2015_113				
Comment Code					
A3 : No rodents visible, but rodent burrows visible; need to backfill and compact or grout burrows.					
Inspector Comment					
A large hole, possibly a rodent hole, is on the waterside slope.

Looking north at large hole on waterward slope.

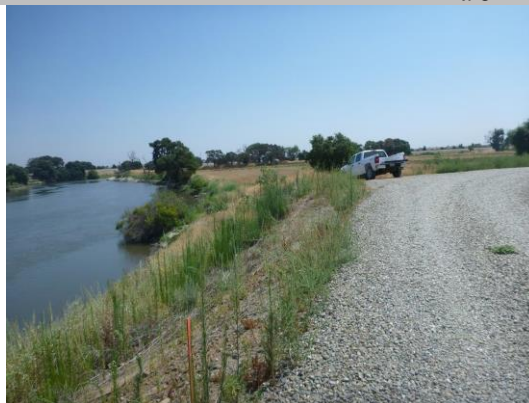
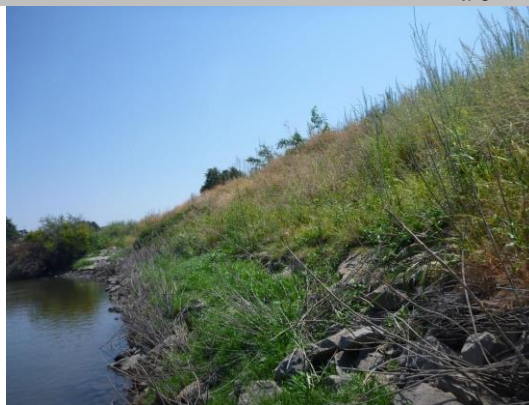
LM Start	4.97	Rating **	A/W	Issue No.	139
LM End	4.99	Issue Type +	Ma	Location *	
Category	Supplemental			GPS Latitude/Longitude	
				Start	End
Item	2017 Storm Damage			37.818600 °	37.818400 °
				-121.319200 °	-121.319000 °
DWR ID	DWR_RD0544_01_f_2017_139				
Comment Code					
Inspector Comment					
Levee Evaluation Comments					
Description:Slope protection repairs are needed along the waterside slope due to erosion and riprap displacement from high water. Based upon levee inspections, it was determined the waterside levee slope is eroding, deteriorating, and degrading. The eroded levee sections need to be restored back to design standards to prevent further deterioration and damage.					
Site ID No:559					
Site Designation:LMA-465					
Repair Type: Erosion					
Rating:Serious					
Field Date:8/11/2017					
Notes:

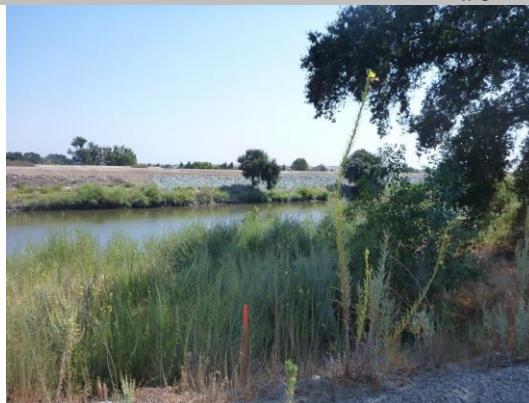
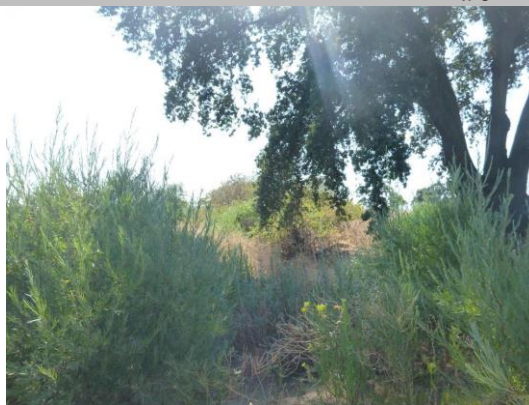
LM Start	5.36	Rating **	A/W	Issue No.	141
LM End	5.37	Issue Type +	Ma	Location *	
Category	Supplemental			GPS Latitude/Longitude	
				Start	End
Item	2017 Storm Damage			37.813400 °	37.813300 °
				-121.319300 °	-121.319200 °
DWR ID	DWR_RD0544_01_f_2017_141				
Comment Code					
Inspector Comment					
Levee Evaluation Comments					
Description:Slope protection repairs are needed along the waterside slope due to erosion and riprap displacement from high water. Based upon levee inspections, it was determined the waterside levee slope is eroding, deteriorating, and degrading. The eroded levee sections need to be restored back to design standards to prevent further deterioration and damage.					
Site ID No:557					
Site Designation:LMA-463					
Repair Type: Erosion					
Rating:Area of Concern					
Field Date:8/16/2017					
Notes:

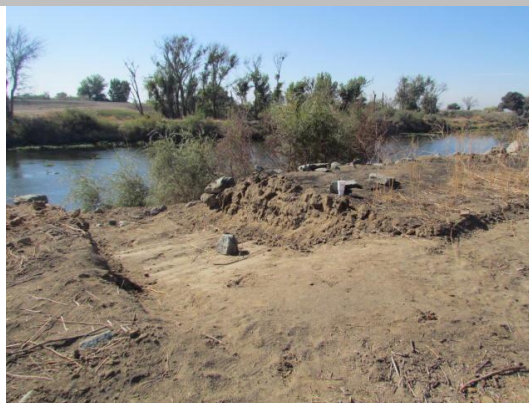
Photo 4 of 4 : SP_2019_RD0544_108_121_20190313_00081.jpg

LM Start	5.60	Rating **	U	Issue No.	121 (cont)
LM End	5.60	Issue Type +	En	Location *	WS

Looking southeast at excavation on waterward berm.

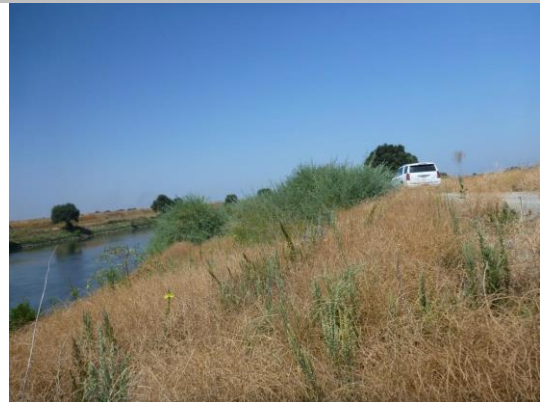
Photo 1 of 3 : LEVAL_SP_2019_556_4520.jpg

LM Start	0.21	Rating **	A/W	Issue No.	37
LM End	0.23	Issue Type +	Ma	Location *	
Category	Supplemental			GPS Latitude/Longitude	
				Start	End
Item	2017 Storm Damage			37.808300 °	37.808400 °
				-121.332000 °	-121.332200 °
DWR ID	DWR_RD0544_02_f_2017_37				
Comment Code					
Inspector Comment					
Levee Evaluation Comments					
Description:Slope protection repairs are needed along the waterside slope due to erosion and riprap displacement from high water. Based upon levee inspections, it was determined the waterside levee slope is eroding, deteriorating, and degrading. The eroded levee sections need to be restored back to design standards to prevent further deterioration and damage.					
Site ID No:556					
Site Designation:LMA-462					
Repair Type: Erosion					
Rating:Area of Concern					
Field Date:8/16/2017					
Notes:

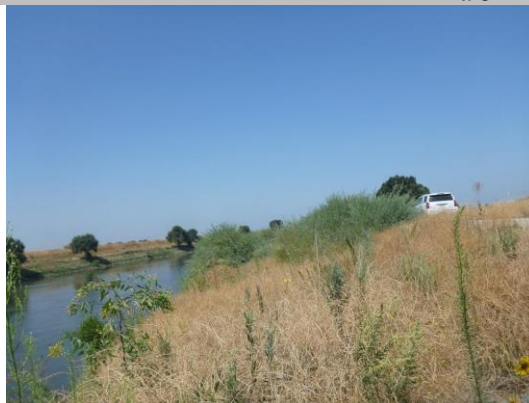
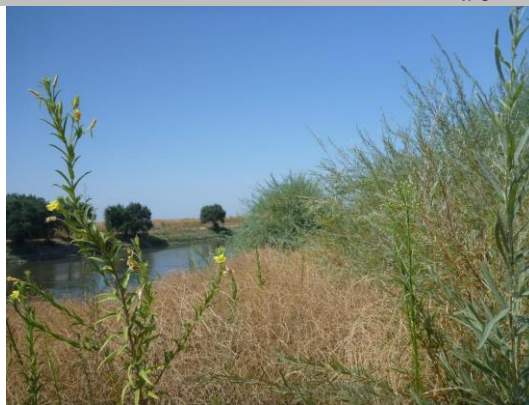
LM Start	0.21	Rating **	A/W	Issue No.	37 (cont)
LM End	0.23	Issue Type +	Ma	Location *	
Category	Supplemental			GPS Latitude/Longitude	
				Start	End
Item	2017 Storm Damage			37.808300 °	37.808400 °
				-121.332000 °	-121.332200 °
DWR ID	DWR_RD0544_02_f_2017_37				
Comment Code					
Inspector Comment					
Levee Evaluation Comments					
Description:Slope protection repairs are needed along the waterside slope due to erosion and riprap displacement from high water. Based upon levee inspections, it was determined the waterside levee slope is eroding, deteriorating, and degrading. The eroded levee sections need to be restored back to design standards to prevent further deterioration and damage.					
Site ID No:556					
Site Designation:LMA-462					
Repair Type: Erosion					
Rating:Area of Concern					
Field Date:8/16/2017					
Notes:

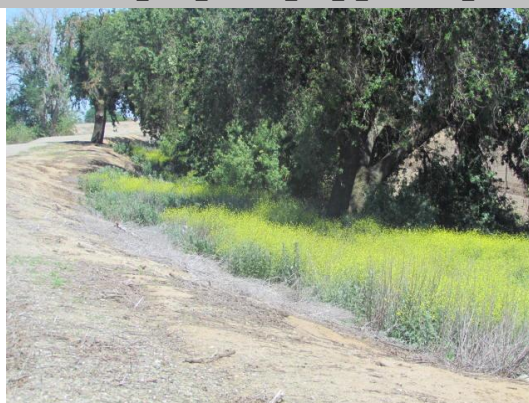
Photo 1 of 1 : SP_2019_RD0544_109_1_20190313_00001.jpg

LM Start	0.43	Rating **	M	Issue No.	1
LM End	1.12	Issue Type +	Ma	Location *	LS
Category	Earthen Levee			GPS Latitude/Longitude	
				Start	End
Item	Vegetation			37.810250 °	37.819452 °
				-121.334933 °	-121.333755 °
DWR ID	DWR_RD0544_02_s_2012_1				
Comment Code					
V2 : Remove the wild growth other than native grasses from the levee slopes.					
Inspector Comment

Looking southwest at dense vegetation at landward toe.

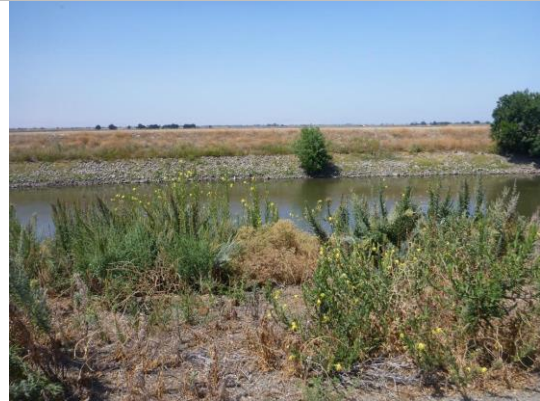
LM Start	0.44	Rating **	A/W	Issue No.	70
LM End	0.46	Issue Type +	Ma	Location *	
Category	Supplemental		GPS Latitude/Longitude		
			Start	End	
Item	2017 Storm Damage		37.810400 °	37.810700 °	
			-121.335000 °	-121.335000 °	
DWR ID	DWR_RD0544_02_f_2017_70				
Comment Code					
Inspector Comment					
<p>Levee Evaluation Comments</p> <p>Description: Slope protection repairs are needed along the waterside slope due to erosion and riprap displacement from high water. Based upon levee inspections, it was determined the waterside levee slope is eroding, deteriorating, and degrading. The eroded levee sections need to be restored back to design standards to prevent further deterioration and damage.</p> <p>Site ID No: 555</p> <p>Site Designation: LMA-461</p> <p>Repair Type: Erosion</p> <p>Rating: Area of Concern</p> <p>Field Date: 8/16/2017</p> <p>Notes:</p>

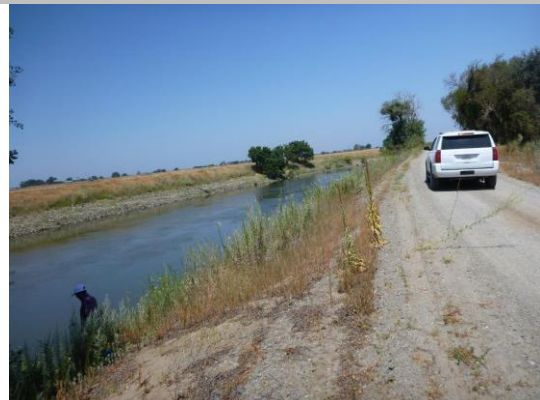
Photo 1 of 3 : LEVAL_SP_2019_554_4630.jpg

LM Start	0.57	Rating **	A/W	Issue No.	80
LM End	0.58	Issue Type +	Ma	Location *	
Category	Supplemental			GPS Latitude/Longitude	
				Start	End
Item	2017 Storm Damage			37.812300 °	37.812400 °
				-121.335100 °	-121.335100 °
DWR ID	DWR_RD0544_02_f_2017_80				
Comment Code					
Inspector Comment					
<p>Levee Evaluation Comments</p> <p>Description: Slope protection repairs are needed along the waterside slope due to erosion and riprap displacement from high water. Based upon levee inspections, it was determined the waterside levee slope is eroding, deteriorating, and degrading. The eroded levee sections need to be restored back to design standards to prevent further deterioration and damage.</p> <p>Site ID No: 554</p> <p>Site Designation: LMA-460</p> <p>Repair Type: Erosion</p> <p>Rating: Area of Concern</p> <p>Field Date: 8/16/2017</p> <p>Notes:</p>

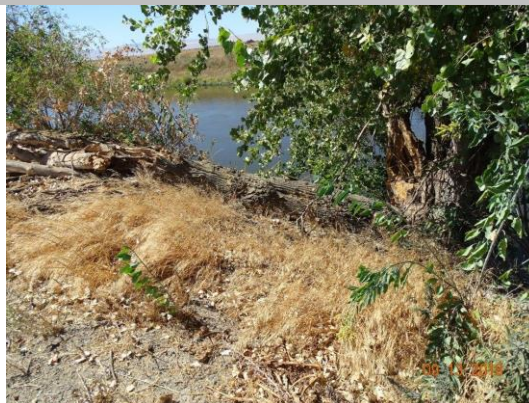
Photo 1 of 2 : SP_2019_RD0544_109_27_20190313_00019.jpg

LM Start	0.64	Rating **	U	Issue No.	27
LM End	0.64	Issue Type +	Ma	Location *	WS
Category	Earthen Levee			GPS Latitude/Longitude	
				Start	End
Item	Encroachments			37.813307 °	37.813307 °
				-121.335135 °	-121.335135 °
DWR ID	DWR_RD0544_02_f_2018_27				
Comment Code					
TR : Tree or limb					
Inspector Comment

Looking east at tree trunk on waterside slope. (Fall 2018)

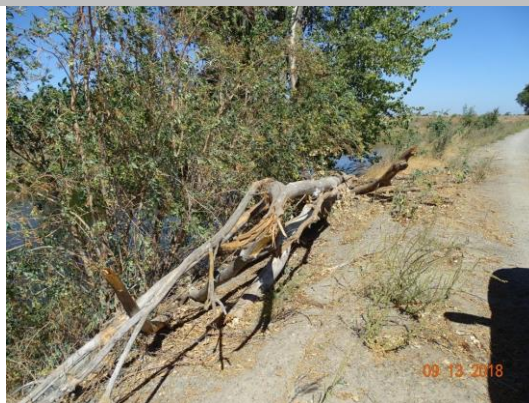
Photo 2 of 2 : SP_2019_RD0544_109_27_20190313_00020.jpg

LM Start	0.64	Rating **	U	Issue No.	27 (cont)
LM End	0.64	Issue Type +	Ma	Location *	WS

Looking southeast at tree limbs on waterward shoulder. (Fall 2018)

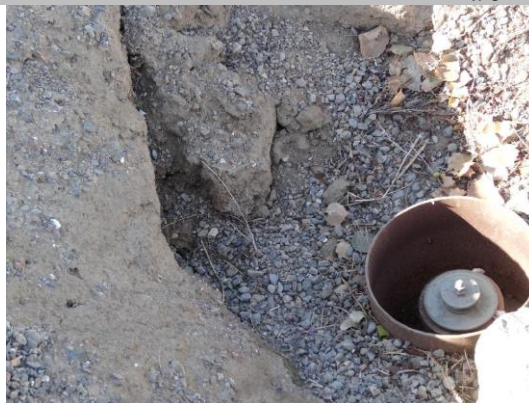
Photo 2 of 3 : UCIP_SP_2019_53366_44881.jpg

Comment Code						
Inspector Comment						
FS_ID:53366 DS_ID:22665 EP_NO: N/A Repair Type: Urgent Crossing Status: Found UCIP Comments: 10/2/2018 Same as last inspection; overgrown vegetation did not allow for visual inspection on LS so remains Urgent due to concern of erosion on WS (D. Sanoski - DWR UCIP).12/22/2016: Same as last inspection. Suspect siphon breaker is leaking due to depression around it. Two giant rodent holes through WS slope at siphon breaker. Siphon breaker is silted in. (K. Fazel - UCIP)10/31/2013:- 8 ft X 7 ft X 4 ft depression around siphon breaker on waterside slope.- no pipe visible on waterside due to dense vegetation.- electric conduit and service pole on landside. (P. Amatya - DWR) FIELD_STRUCT_DESC: 12-inch steel drainage discharge pipe through the levee, 4 feet below the crown. Pump in a drainage ditch off the landside (LS) toe. Siphon breaker on the waterside (WS) slope. [Additional Reference(s): DWR Levee Log, 2005]. FS Date: 10/2/2018 4:06:00 PM

WS view: depression on levee slope around siphon breaker. Siphon breaker in steel pipe riser.

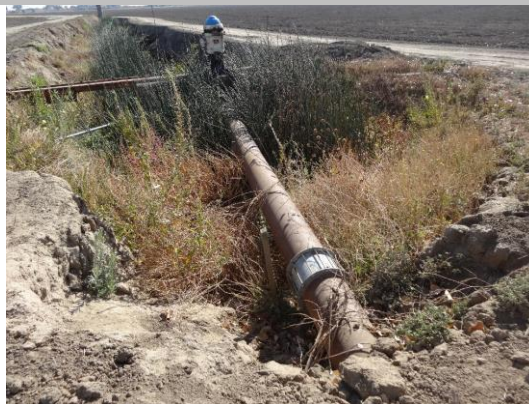
Photo 3 of 3 : UCIP_SP_2019_53366_44880.jpg

LS view: pump on timber support in drainage ditch. About 150 ft from levee center.

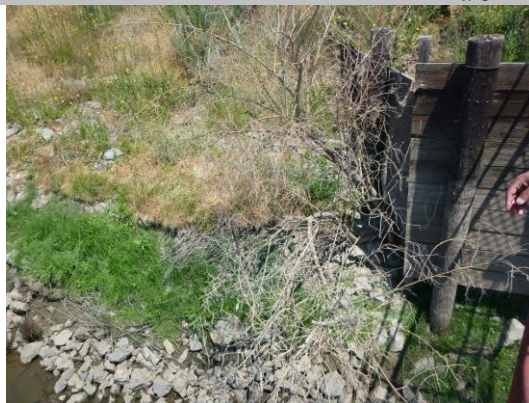
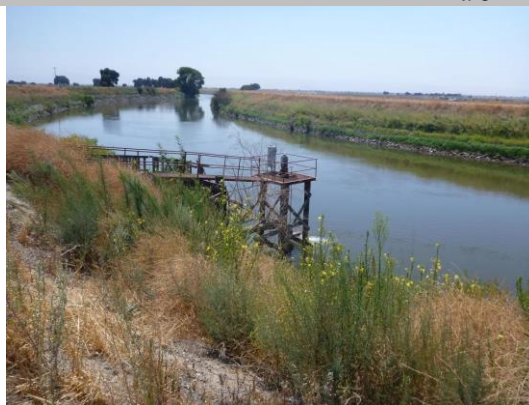
LM Start	1.01	Rating **	A/W	Issue No.	82 (cont)	
LM End	1.02	Issue Type +	Ma	Location *		
Category	Supplemental			GPS Latitude/Longitude		
				Start		End
Item	2017 Storm Damage			37.818100 °		37.818200 °
				-121.332800 °		-121.332800 °
DWR ID	DWR_RD0544_02_f_2017_82					
Comment Code						
Inspector Comment						
Levee Evaluation Comments						
Description:Slope protection repairs are needed along the waterside slope due to erosion and riprap displacement from high water. Based upon levee inspections, it was determined the waterside levee slope is eroding, deteriorating, and degrading. The eroded levee sections need to be restored back to design standards to prevent further deterioration and damage.						
Site ID No:552						
Site Designation:LMA-458						
Repair Type: Erosion						
Rating:Area of Concern						
Field Date:8/16/2017						
Notes:

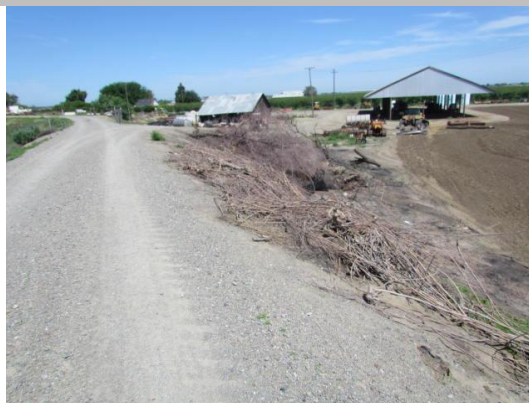
Photo 1 of 1 : SP_2019_RD0544_109_20_20190313_00014.jpg

LM Start	1.12	Rating **	M	Issue No.	20
LM End	1.12	Issue Type +	En	Location *	LS
Category	Earthen Levee			GPS Latitude/Longitude	
				Start	End
Item	Encroachments			37.819530 °	37.819530 °
				-121.333827 °	-121.333827 °
DWR ID	DWR_RD0544_02_s_2012_20				
Comment Code					
PR : Prunings					
Inspector Comment					
Landowner is stock piling prunings on landside slope and toe.

Looking southwest at pruning piles on landward slope.

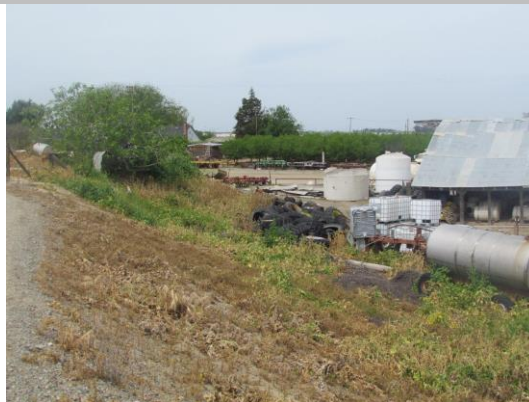
Photo 1 of 2 : SP_2019_RD0544_109_25_20190313_00017.jpg

LM Start	1.13	Rating **	U	Issue No.	25	
LM End	1.22	Issue Type +	En	Location *	LS	
Category	Earthen Levee			GPS Latitude/Longitude		
				Start		End
Item	Encroachments			37.819560 °		37.820247 °
				-121.333893 °		-121.335337 °
DWR ID	DWR_RD0544_02_s_2012_25					
Comment Code						
EQ : Equipment						
Inspector Comment

Looking south at farm equipment stored on landward shoulder and slope.

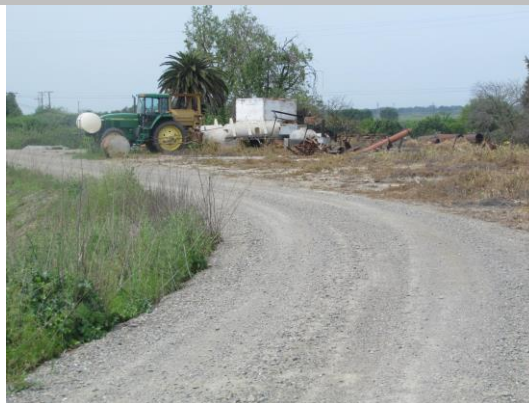
Photo 2 of 2 : SP_2019_RD0544_109_25_20190313_00018.jpg

LM Start	1.13	Rating **	U	Issue No.	25 (cont)	
LM End	1.22	Issue Type +	En	Location *	LS	
Category	Earthen Levee			GPS Latitude/Longitude		
				Start		End
Item	Encroachments			37.819560 °		37.820247 °
				-121.333893 °		-121.335337 °
DWR ID	DWR_RD0544_02_s_2012_25					
Comment Code						
EQ : Equipment						
Inspector Comment

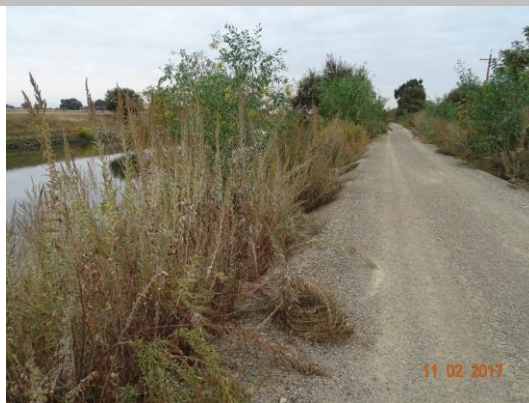
Photo 1 of 1 : SP_2019_RD0544_109_101_20190313_00087.jpg

LM Start	1.29	Rating **	U	Issue No.	101
LM End	1.56	Issue Type +	Ma	Location *	WS
Category	Earthen Levee			GPS Latitude/Longitude	
				Start	End
Item	Vegetation			37.820668 °	37.822239 °
				-121.336491 °	-121.340589 °
DWR ID	DWR_RD0544_02_f_2017_101				
Comment Code					
V2 : Remove the wild growth other than native grasses from the levee slopes.					
Inspector Comment

Looking northwest at the waterside slope.

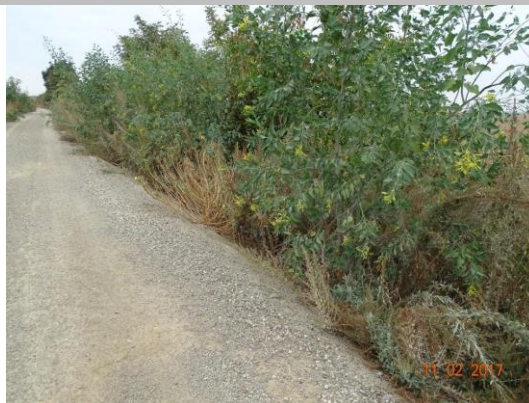
Photo 1 of 1 : SP_2019_RD0544_109_102_20190313_00088.jpg

LM Start	1.29	Rating **	U	Issue No.	102
LM End	1.56	Issue Type +	Ma	Location *	LS
Category	Earthen Levee			GPS Latitude/Longitude	
				Start	End
Item	Vegetation			37.820668 °	37.822239 °
				-121.336491 °	-121.340589 °
DWR ID	DWR_RD0544_02_f_2017_102				
Comment Code					
V2 : Remove the wild growth other than native grasses from the levee slopes.					
Inspector Comment

Looking northwest at the landside slope.
